# Building Inspection Report

**Inspector:**  
DEREK DOBYNS

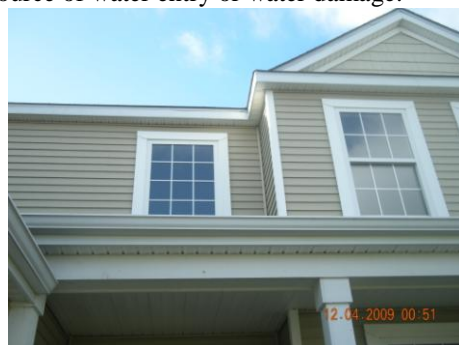
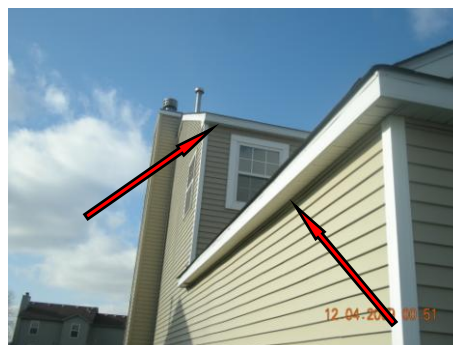
- **Improve:** There does not appear to be a sufficient number of downspouts. If practical, additional downspouts should be installed to avoid spilling roof runoff around the building – a potential source of water entry or water damage.
- **Improve:** The downspout(s) should discharge water at least five (5) feet from the house. Storm water should be encouraged to flow away from the building at the point of discharge.
- **Improve:** It is recommended that gutters and downspouts be installed to avoid spilling roof runoff around the building – a potential source of water entry or water damage.

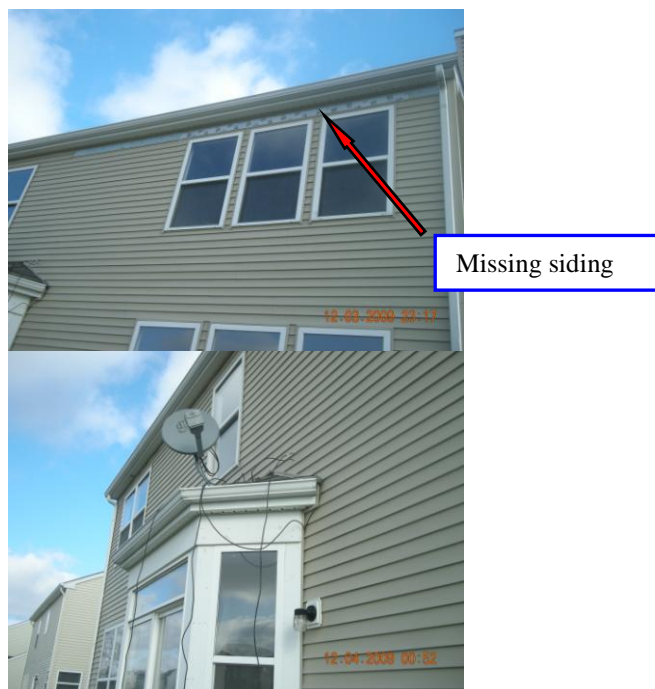
- **Repair:** The missing siding on South West side of house should be replaced to avoid wind or water damage.
- **Repair:** Unused Sattalite Dish and cable should be removed and Holes repaired
-

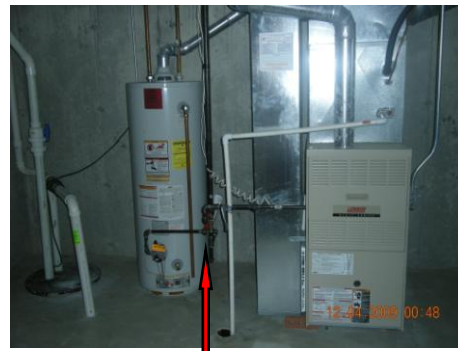
Gas shutoffs

The heating system is in generally good condition.

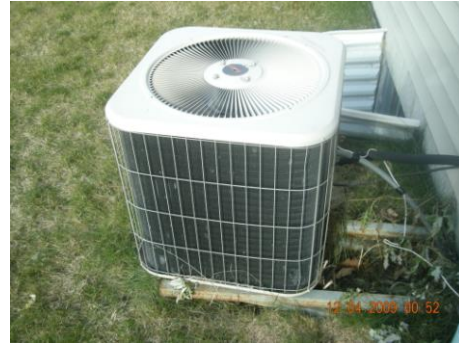
- 240 Volt Power Supply
- Air Cooled Central Air Conditioning •Manufacturer: Lennox•Serial Number: 5804B17126

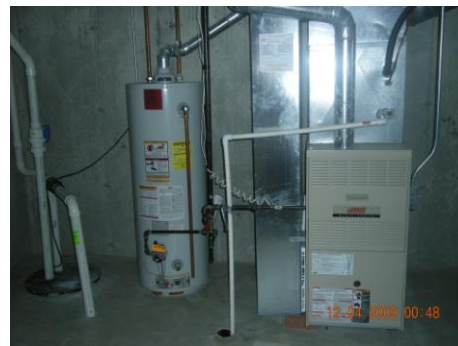
- Interior Supply Piping:** •Copper  
**Waste System:** •Public Sewer System  
**Drain, Waste, & Vent Piping:** •Plastic  
**Fuel Shut-Off Valves:** •Natural Gas Main Valve At North East corner outside of house  
**Other Components:** •Sump Pump •Laundry Tub Pump  
**Water Heater:** •Gas •Approximate Capacity (in gallons): 50  
 •Manufacturer: State •Serial Number: E04337187

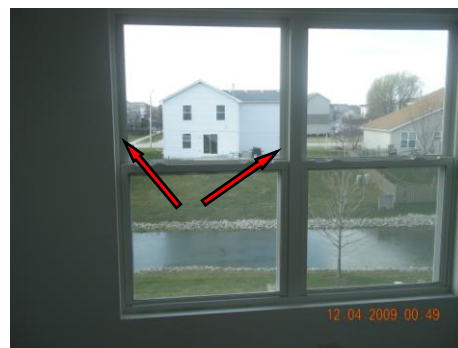
- **Repair:** Window hardware is damaged. Window in upstairs north west room lacks springs will fall if opened and released

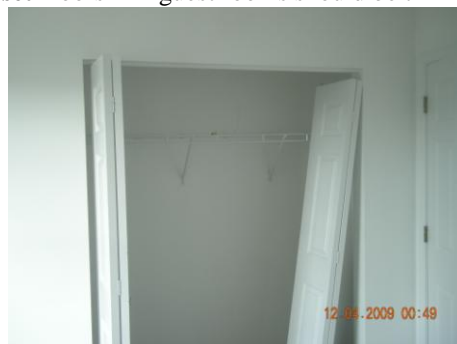
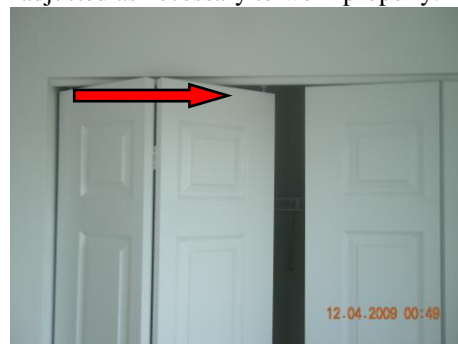
- **Repair:** Closet Doors in 2 guest rooms should be trimmed or adjusted as necessary to work properly.

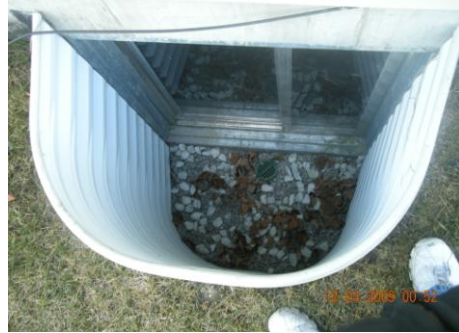
- **Improve: Window well covers are recommended for safety**
- **Improve possible safety Issue: window well egress in basement should have a ladder for emergency exit**
